Manhole Inspection Summary

Manhole # S33KK1012MH

Insp Date: **3/21/07 3:08 PM**

Location Address: **4209 SAINT PAUL ST**

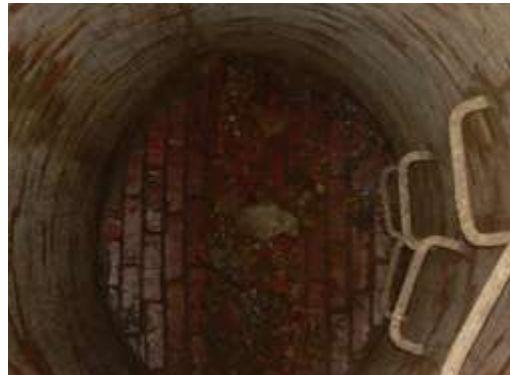
Top View

Channel debris

2" PVC pipe

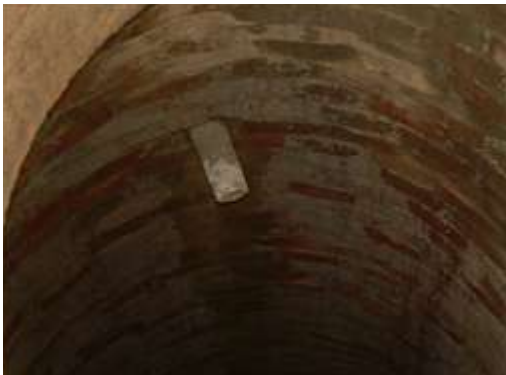
Possible illicit connection.

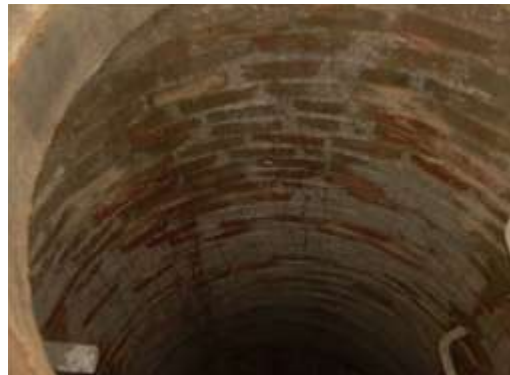
Defect

Frame leaks. Corbel and Barrel infiltration.

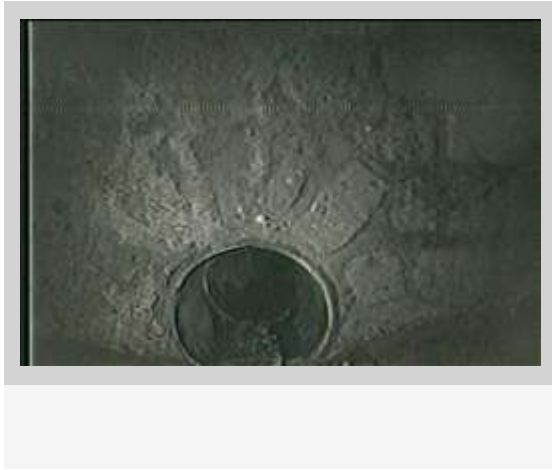
6 in. Circular Gravity Sewer
Pipe Out @ 12 O'Clock

Deposits: ☐ None ☒ **Mud** ☐ Sludge ☒ **Debris** ☐ Grease

Silt Depth: **0.5** (in.) Deposits Extent: **Light**

Infiltration: **Evidence** Pipe Seal Cond: **Unknown**
